INDOOR AIR QUALITY ASSESSMENT

**Tadgell Hall Elementary School
7 Berkshire Avenue
Belchertown, Massachusetts**

Prepared by:
Massachusetts Department of Public Health
Center for Environmental Health
Bureau of Environmental Health Assessment
Emergency Response/Indoor Air Quality Program
June 2004

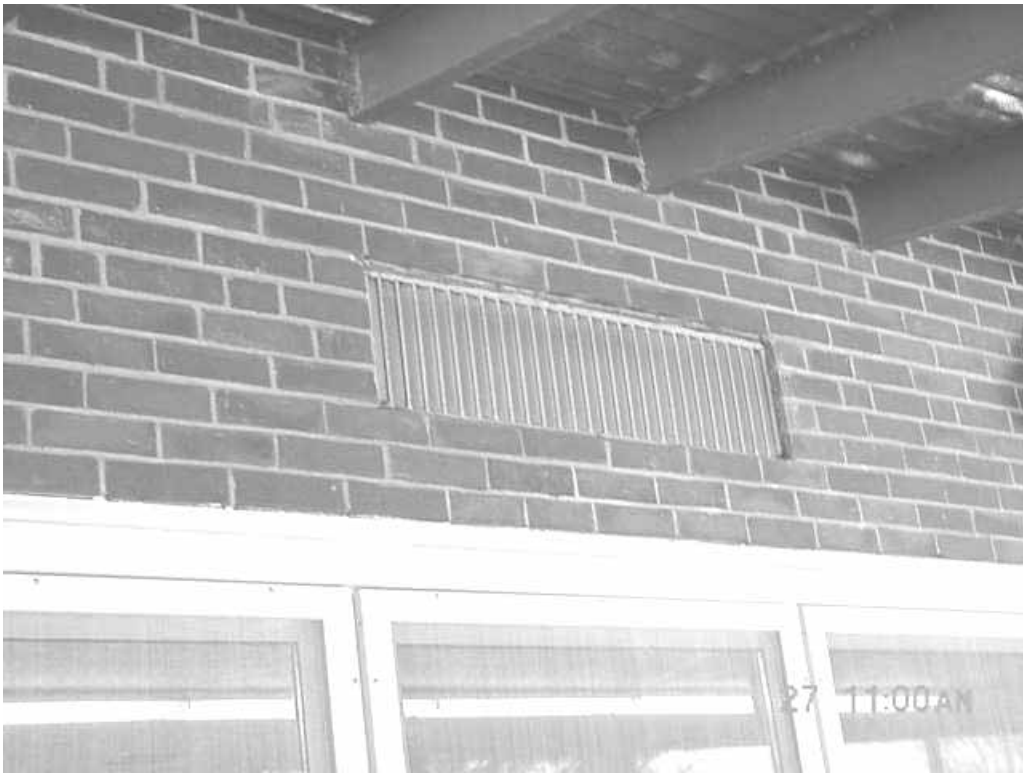
Picture 1

It can be seen from Table 1 that carbon dioxide levels were elevated above 800 parts per million of air (ppm) in eight of ten areas surveyed, indicating inadequate ventilation in the majority of areas surveyed. Fresh air in classrooms is supplied by a unit ventilator (univent) system. Univents draw air from outdoors through a fresh air intake located on the exterior walls of the building (Picture 1) and return air through an air intake located at the base of each unit ([Figure 1](#)). Fresh and return air are mixed, filtered, heated and provided to classrooms through an air diffuser located in the top of the unit. The majority of univents were not operating during the assessment. Obstructions to airflow, such as papers and books stored on univents and items placed in front of univent returns, were seen in a number of classrooms (Picture 2). In order for univents to provide fresh air as designed, they must remain operating while rooms are occupied. In addition, intakes must remain free of obstructions.

Univent Fresh Air Intake

1. Survey classroom univents to ascertain function and determine whether an adequate air supply exists for each room. Consider consulting a heating, ventilation and air conditioning (HVAC) engineer concerning the calibration of univent fresh air control dampers throughout the school.

2. Operate all ventilation systems throughout the building (e.g., gym, cafeteria, classrooms) continuously during periods of school occupancy and independent of thermostat control to maximize air exchange. To increase airflow in classrooms, set univent controls to “high”.

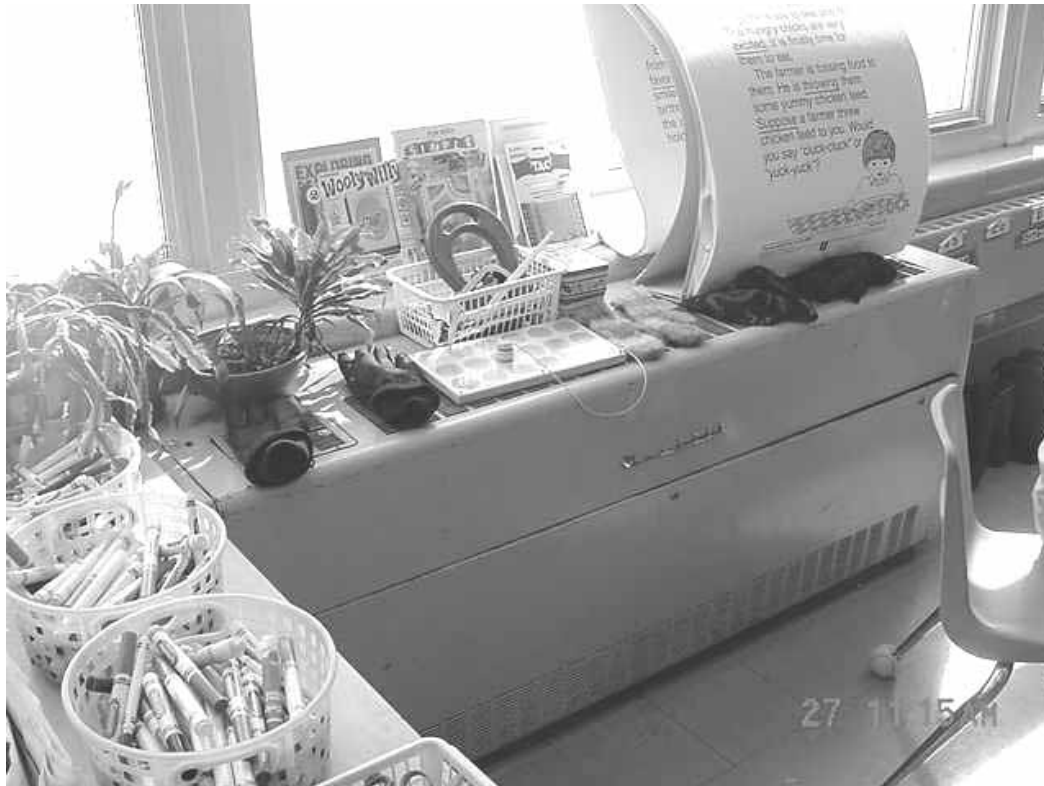
Picture 2

Items on Univent Obstructing Airflow

3. Inspect rooftop exhaust motors and belts for proper function, repair and replace as necessary.
4. Remove all blockages from univents and exhaust vents.

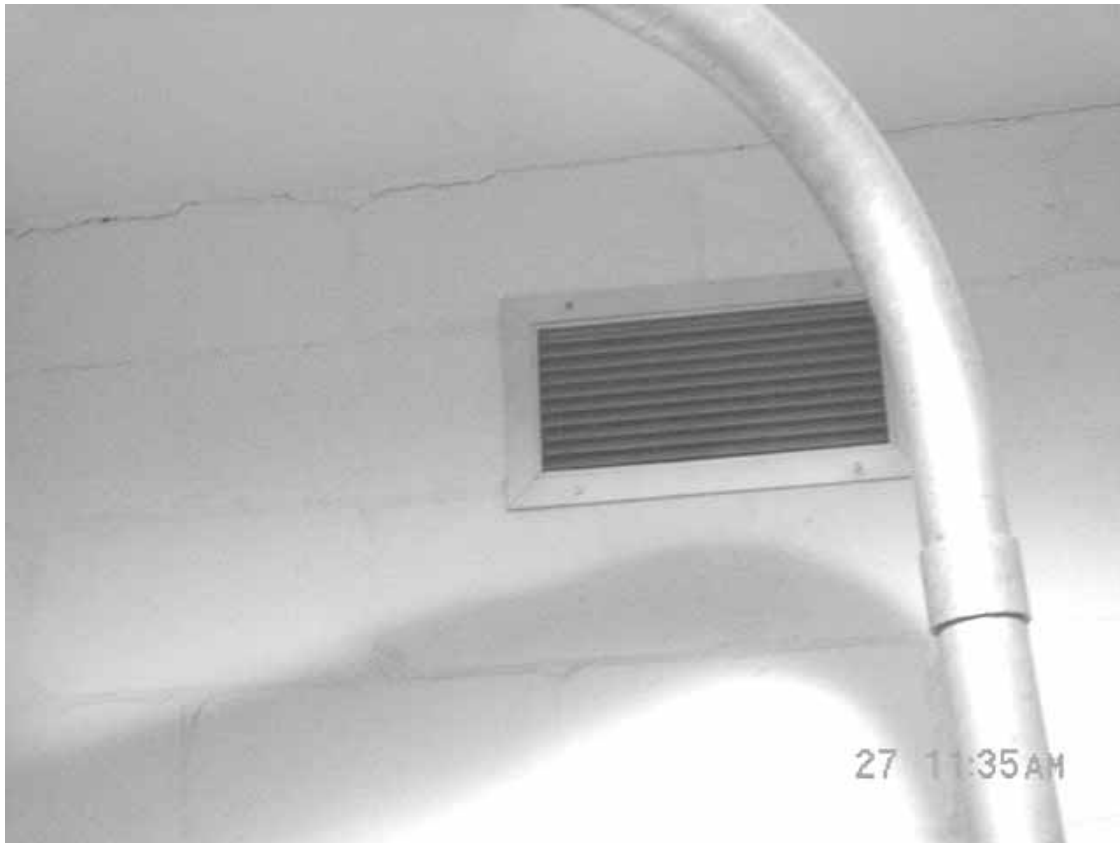
Picture 3

Exhaust ventilation in some classrooms consists of wall-mounted vents (Picture 3) powered by rooftop motors. The exhaust system was not drawing in a number of areas

surveyed, indicating that motors had been deactivated or non-functional. Classrooms that were formerly nurse's stations were designed to provide exhaust ventilation via passive vents installed in the hallway doors. As fresh outside air was mechanically introduced by univents, the rooms would become pressurized, forcing exhaust air out the passive door vents. However, these door vents are now sealed (Picture 4), preventing air exchange as originally designed. Without adequate exhaust ventilation, excess heat and environmental pollutants can accumulate and lead to indoor air complaints.

Wall-Mounted Exhaust Vent

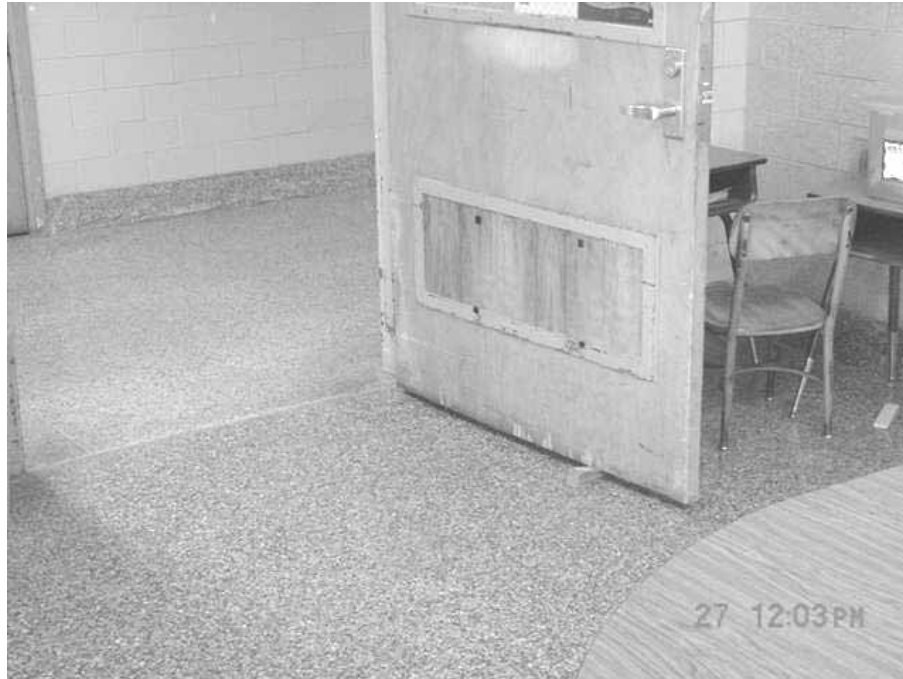
Picture 4

Sealed Passive Vent in Classroom Door

5. Consider providing mechanical exhaust or reinstall passive vents in classroom doors to provide air exchange.
6. Consider balancing mechanical ventilation systems every 5 years, as recommended by ventilation industrial standards (SMACNA, 1994).

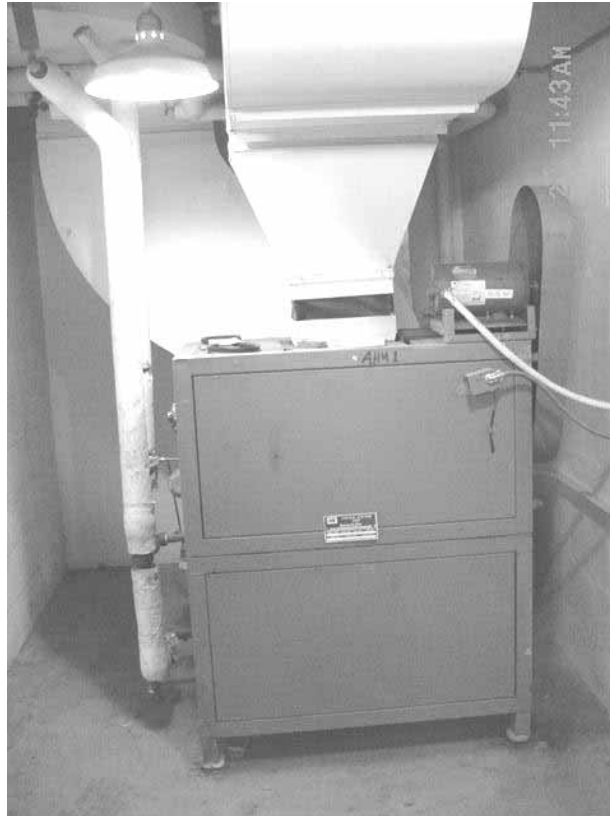
Picture 5

Mechanical ventilation in ground floor areas (cafeteria, gym, art room) is provided by an air handling unit (AHU) located in a mechanical room (Picture 5). Fresh air is distributed by ceiling or wall-mounted air diffusers via ductwork. Return air is drawn into wall or ceiling exhaust vents ducted back to the AHU. This system was operating during the assessment.

AHU in Ground Floor Mechanical Room

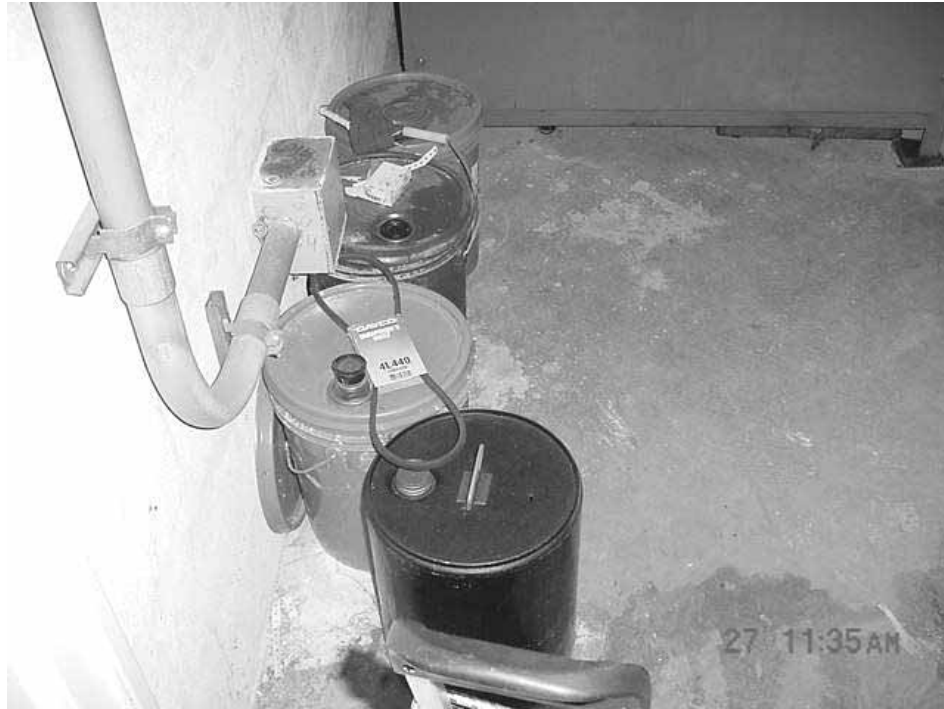
Picture 6

An elevator shaft located on the ground floor contained several containers of hydraulic fluid (Picture 6). A slight odor of hydraulic fluid was detected upon entering the mechanical room. BEHA staff recommended that maintenance staff ensure that containers of hydraulic fluid and other hazardous substances be securely sealed after use to prevent the migration of odors. The movement of the elevator in the shaft can act like a piston, pressurizing and depressurizing air in the elevator shaft, which can then force and draw odors into other areas of the building. Several classrooms contained dry erase boards and dry erase markers. Materials such as dry erase markers and dry erase board cleaners may contain VOCs (e.g., methyl isobutyl ketone, n-butyl acetate and butyl-cellusolve) (Sanford, 1999), which can be irritating to the eyes, nose and throat. Spray-cleaning products were found on countertops and in unlocked storage cabinets beneath sinks in classrooms. Cleaning products contain chemicals that can be irritating to the eyes, nose and throat. Cleaning products should be stored properly and kept out of reach of students.

Containers of Hydraulic Fluid in Elevator Shaft Mechanical Room

9. Remove plant growths against the exterior wall/foundation of the building to prevent water penetration. Trim trees away from brickwork.
10. Ensure containers of hydraulic fluid in elevator shaft mechanical room are properly secured to prevent the migration of odors.

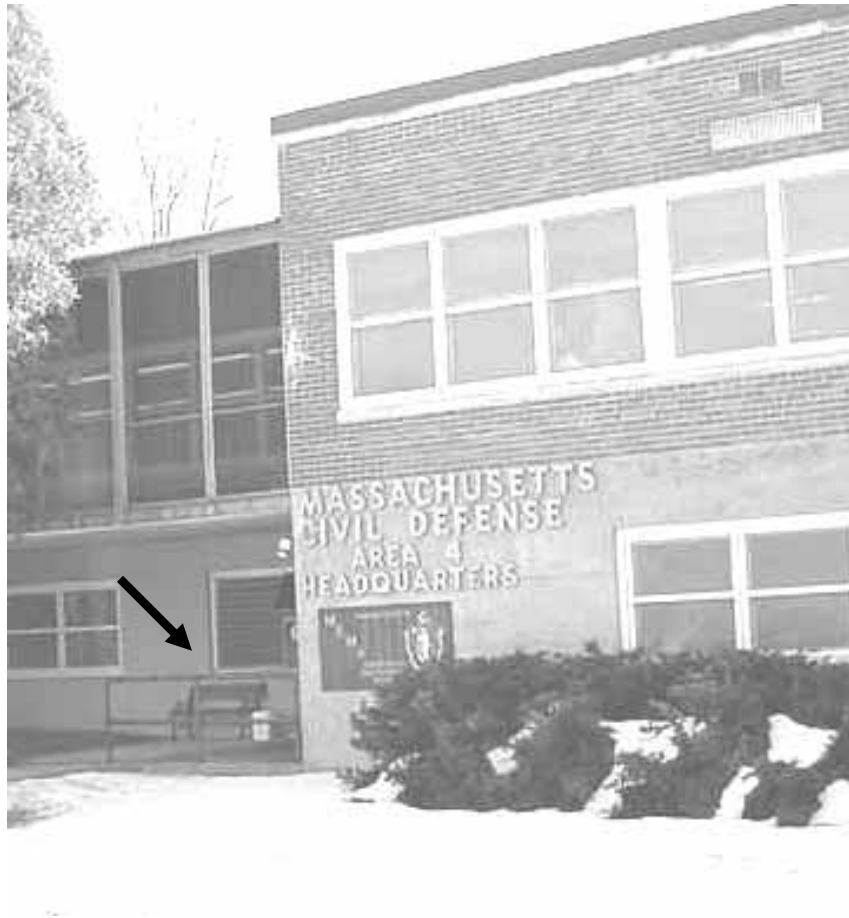
Picture 7

Finally, one of the issues prompting the inspection was concerns of environmental tobacco smoke (ETS). As mentioned, the rear of the building is used for office space not associated with school operations. Occupants of this part of the building reportedly smoke outside of the rear of the building. An air intake for offices appears to be located on the exterior wall in this area (Picture 7). The proximity of the vent to the smoking area can lead

Mechanical Air Vent and Smoking Area for MEMA

15. Consider discussing the relocation of the smoking area in the rear of the building with MEMA staff. If not feasible, seal passive vents in cafeteria hallway to prevent smoke/odor migration.
16. Consider adopting the US EPA (2000) document, Tools for Schools, in order to provide self assessment and maintain a good indoor air quality environment at your building. The document is available at <http://www.epa.gov/iaq/schools/index.html>.
17. Refer to the resource manual and other related indoor air quality documents for further building-wide evaluations and advice on maintaining public buildings. These documents are located on the MDPH's website:
<http://www.state.ma.us/dph/beha/iaq/iaqhome.htm>.

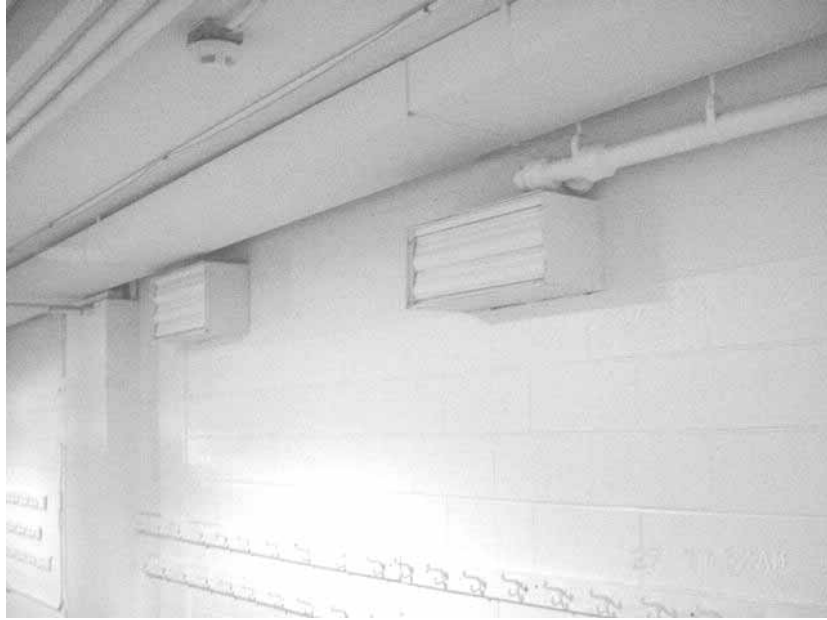
Picture 8

to possible entrainment of ETS into occupied areas of the building. The offices and the school share a common wall on the ground floor, near the cafeteria. Two passive vents were observed in this shared wall (Picture 8). These passive vents allow free transfer of air (and possible smoke odors) between the offices and the school.

Passive Vents in Cafeteria Hallway
